Vista T4/T2

TBJLT114.doc

Vista T4/T2 Battery Replacement

The backup battery within the CPU tray requires replacement as the console ages – a flat battery results in the console losing its CMOS settings. This document describes the battery replacement procedure for Vista version 1 consoles.

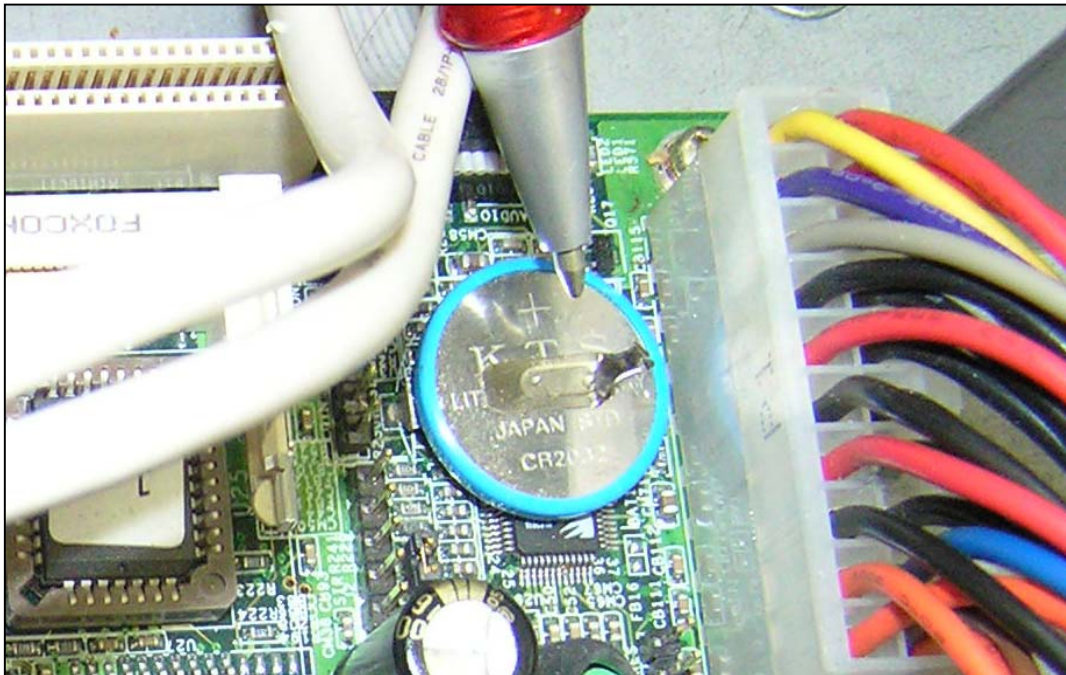
6. Using the side cutters cut the top (+) battery lead between the weld and the edge of the battery. It may be necessary to push the battery down toward the PCB to get enough space for the side cutters.

7. Lift the loose edge of the battery upward to gain access to the remaining battery terminal.
8. Using the soldering iron, remove the old battery and the remains of the + terminal.

9. Insert the new battery + terminal into the PCB, then tilt the battery upward and solder the + terminal to the board.
10. Tilt the battery back to the horizontal and insert the – terminal into the board. Solder the – terminal to the board.

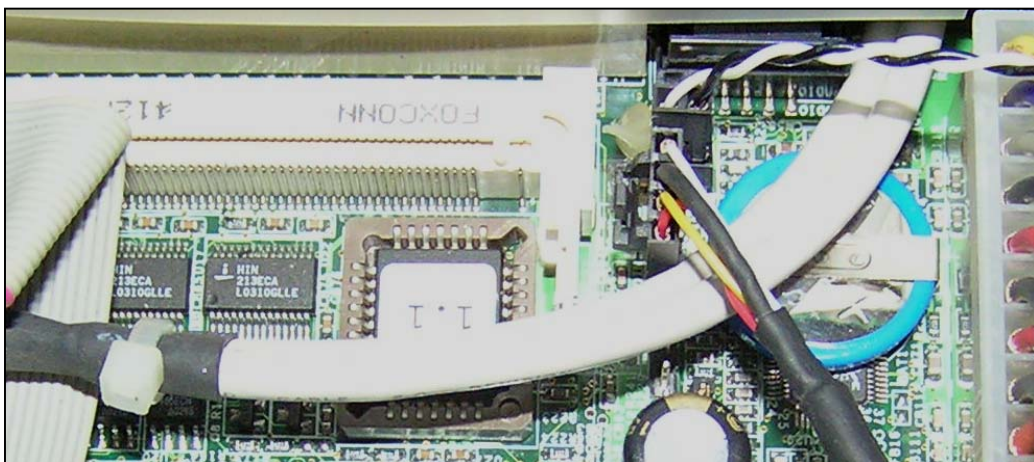
11. Reassemble the CPU tray, verifying all connections against the photograph taken in step #3 and/or the one below. Double-check the wiring in the vicinity of the main power connector.
